Simrad EK Mission Planner

Software Release Note 3.3.0

- **Product:** EK Mission Planner
- **Software version:** 3.3.0

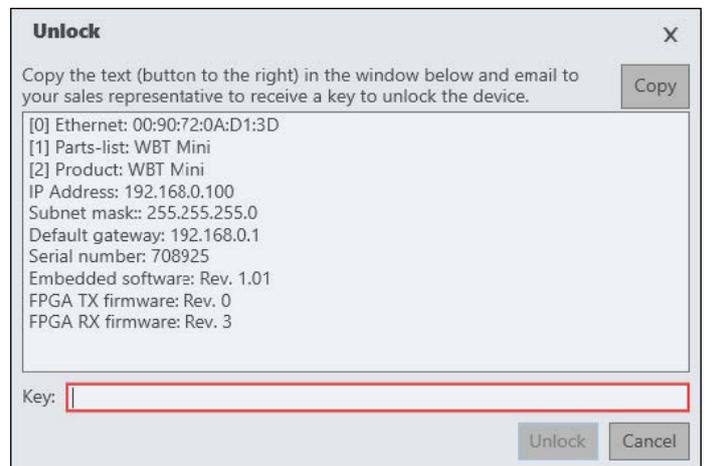
If you are upgrading from a version lower than 3.2.1, the autonomous functionality may be locked.

The EK Mission Planner detects that the instrument is locked and presents a dedicated dialog box to unlock it. Copy the information in the dialog box, and send to ivar.wangen@simrad.com to receive your unlock code.

Type in the unlock code in the red field and select **Unlock**.
